McCarty, Warren Roberts

Crash of Supermarine Stranraer 916
Stuart Channel, BC, Canada

Details of Crash

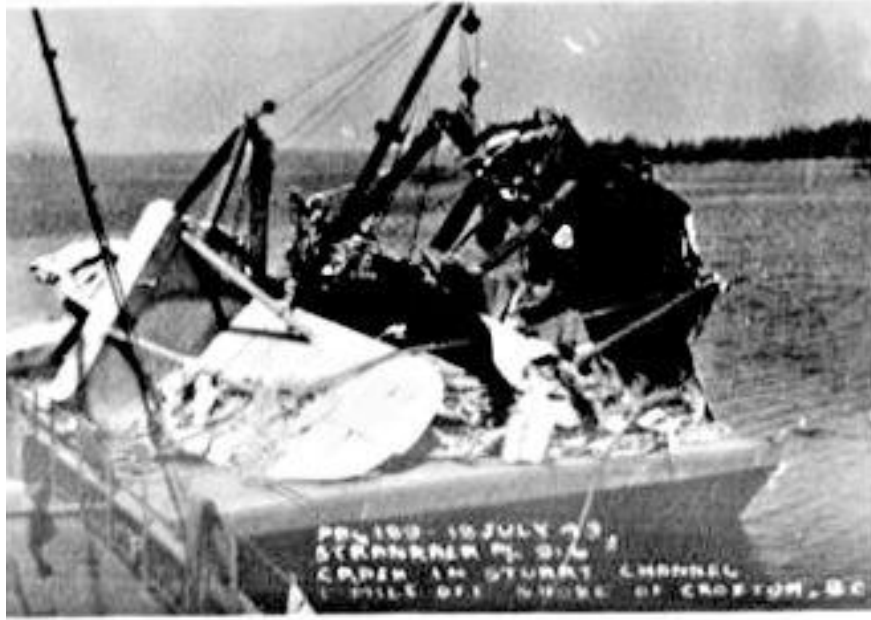
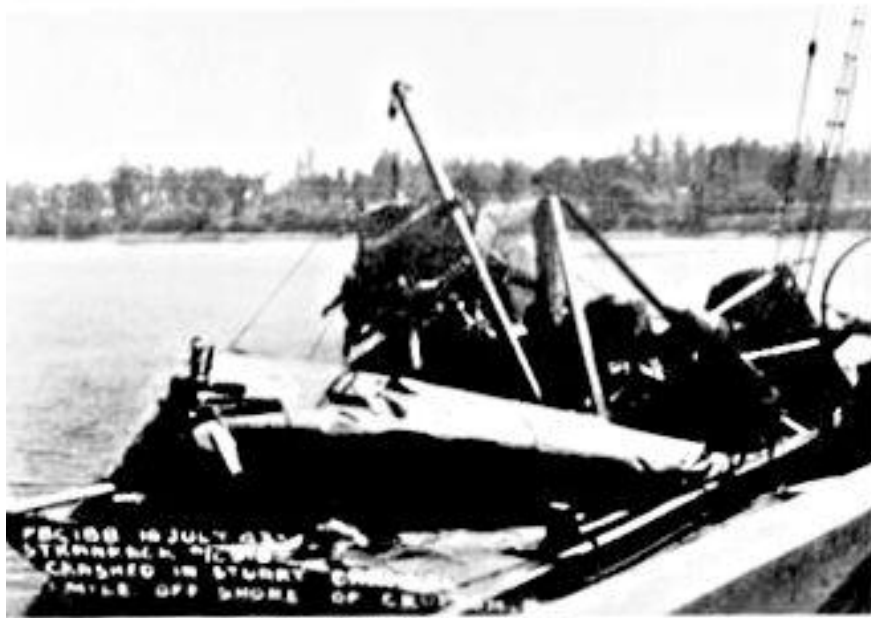
Prior to the accident the aircraft was in perfect serviceable order and all of the crew had Mae Wests. When the severely damaged aircraft was salvaged on July 24th, the body of LAC Bell was still in the fuselage. The Medical Officer who examined him was of the opinion that he had suffered concussion rendering him unable to escape and had thus drowned. No trace was ever found of F/S McCarty.

The conclusion was that the accident was caused by pilot error in that he misjudged the height above a glassy sea and landed nose down.

Stranraer 916 during salvage

The recommendation was a review of the instructions given to pilots for landing on a glassy sea.

Because the survivors had all suffered head trauma and this had contributed to the death of LAC Bell, a recommendation was made that helmets be provided.
