Kimpton, Peter Adrian

crash of Bristol Beaufort W6473
Rodeo, N.M. USA

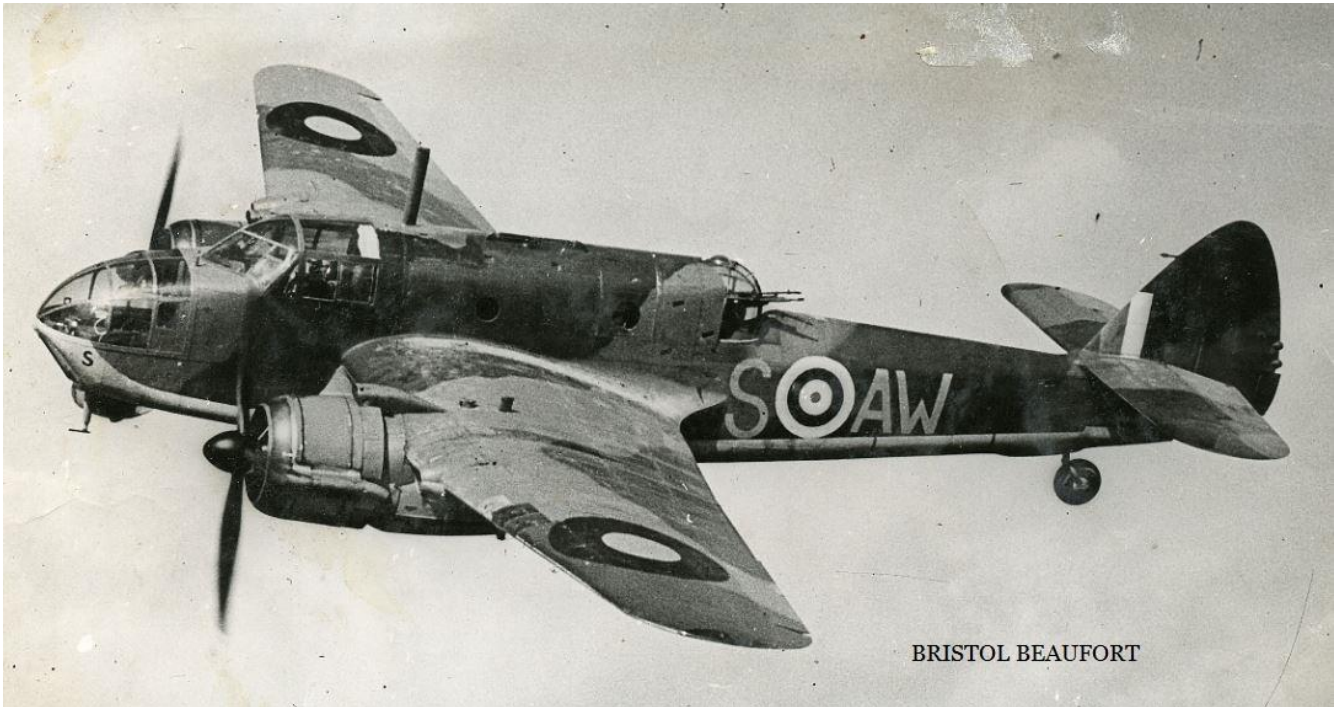
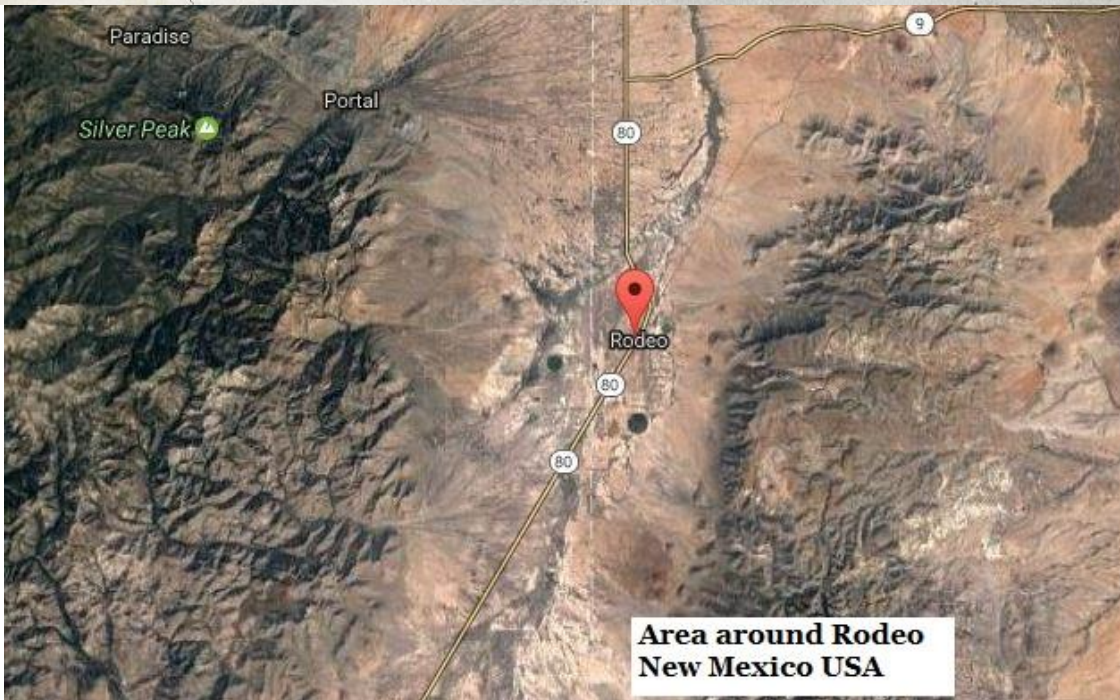
After flying for just over an hour, Beaufort W6473 passed over Rodeo landing ground and very soon afterwards the port engine started running roughly. The only symptom noticed by the pilot was 'fluffing' or minor explosions of the mixture in the intake.

The pilot decided to land at Rodeo and after completing a turn the engine ran rough for an extremely short time and then appeared to drop from the aircraft. At this time, they were at about 100 metres feet in altitude, travelling west towards Rodeo. A minor fire started on the port side, which was out by the time the aircraft reached the ground.

The pilot landed in the desert and the aircraft came to a stop after about 200 metres, about 30 metres from the road. The landing was extremely rough and the starboard propeller and reduction gear were pulled from the engine, and the complete engine was wrenched from its bearers.

Almost immediately, a fire started on the starboard wing and the S/L Lloyd, Corporal Jones and AC1 West managed to get out with no more than minor injuries. F/L Kimpton, the navigator, was thrown forward by the impact and trapped. Efforts were immediately made to hack away the nose with an axe carried in the aircraft, in order to release Kimpton. The heat of the fire proved too much for the release to be successful and F/L Kimpton did not survive.

“The accident was due to mechanical breakdown in the port engine which resulted in the engine falling free and setting fire to the aircraft in flight. This mechanical failure was due to breaking of the crank shaft. Sqn. Ldr. Lloyd should be officially commended for his coolness and skill in landing the aircraft, after the engine had fallen from it in the air and thereby reducing his chance of regaining control.”
